Could be your new home San Antonio, TX -

Rod Inspects
Professional Real Estate Inspections
Rod Stewardson (Owner/Operator) TREC#6291

PROPERTY INSPECTION REPORT

Report #: NewHmWebSmple _____
Prepared For: _____
(Name of Client)
Concerning: Could be your new home, San Antonio, TX - _____
(Address of Inspected Property)
By: Rod Stewardson, #6291 _____ 01/10/2008
(Name and License Number of Inspector) (Date)

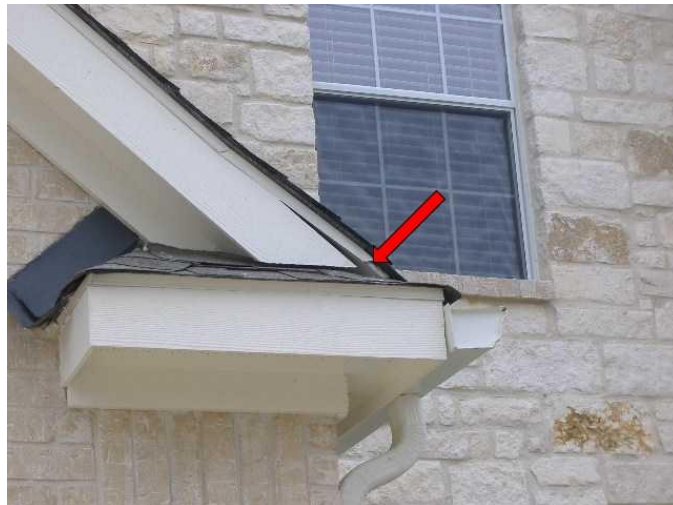
p	"	"	p	<p>C. Roof Covering (If the roof is inaccessible, report the method used to inspect.) <i>Comments:</i></p> <ul style="list-style-type: none"> • Type of Roof Covering: Composition Shingle, Inspected from the roof where pitch and safety allow access. Not all areas were walked. Roof covering wet at time of inspection. • Recommend further evaluation/repair by Professional Roofing Contractor. <p>1. Exposed roof sheathing is present at some roof edges. Blowing rain can penetrate unprotected sheathing and cause water expansion/damage. Front middle gable, rear left.</p>
---	---	---	---	--

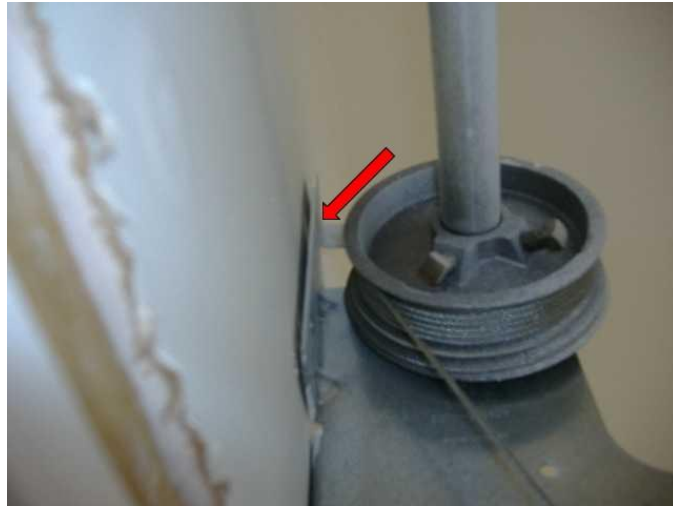
- Garage door spring attach brackets do not have bolts installed in all the bracket openings.

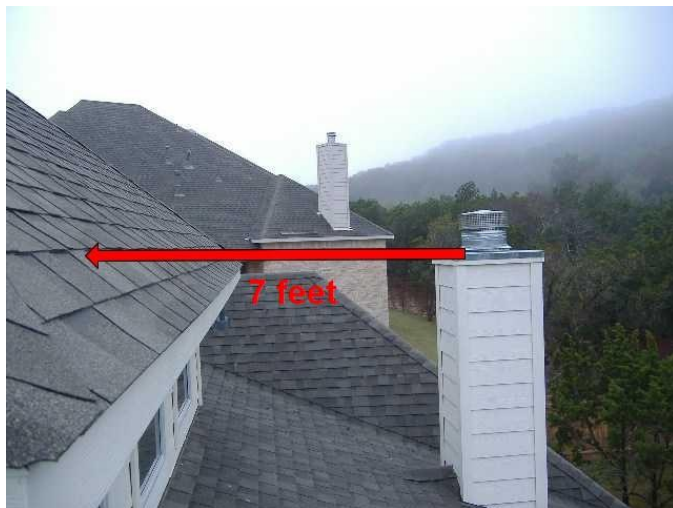
- The chimney may not be high enough to provide for proper drafting. Termination. Chimneys shall extend at least 2 feet higher than any portion of a building within 10 feet, but shall not be less than 3 feet above the highest point where the chimney passes through the roof.

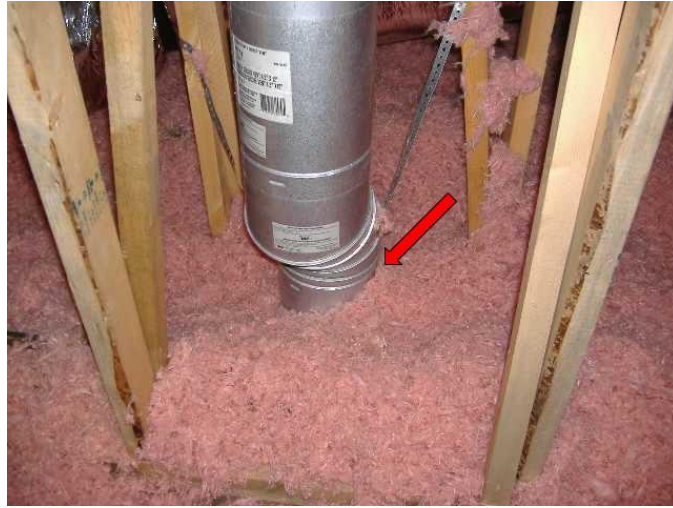
- The chimney flue pipe is in contact with attic insulation. The placard on the flue pipe clearly states that an airspace should be maintained between insulation and building materials.

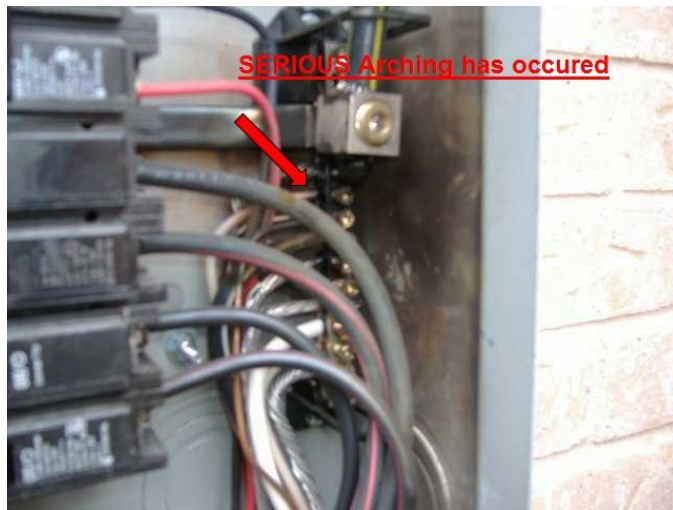
- Note: Some breakers were off at the time of the inspection. Breakers were not re-set to check for power. Cooktop.
- 1. Wire insulation is scorched (evidence of arcing) at the main wire connection (neutral bus side). Recommend further evaluation.

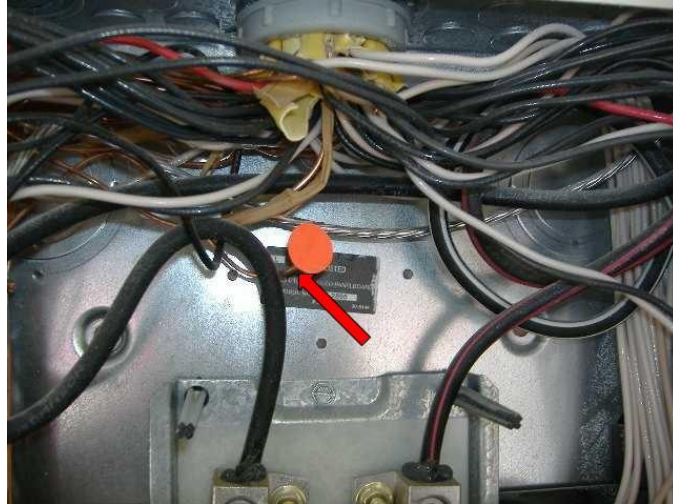
- AFCI(s) breaker does not test properly when the TEST button is pushed. Lower right breaker. Smoke alarm.
- Ground wire is loose and not connected to the ground bus bar. (see orange dot)

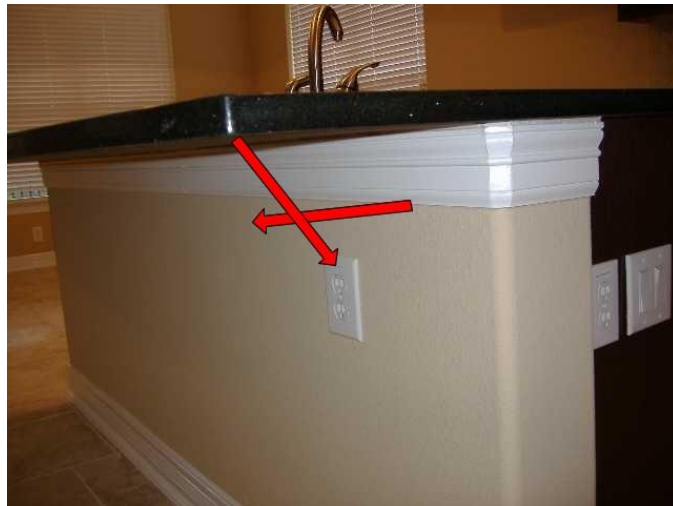
- The front island/peninsula receptacle is improperly installed. The counter-top overhang cannot be more than 6".

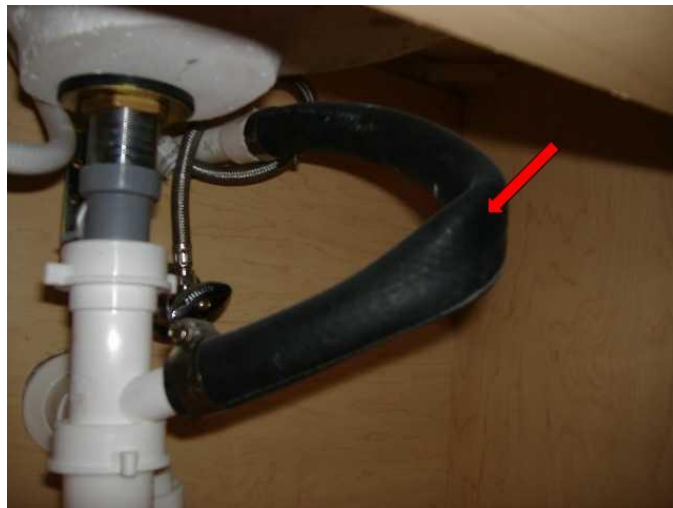
1. Condensation drain line under the bath sink is partially kinked and may restrict proper flow from the HVAC unit. Under upper hall bath sink.

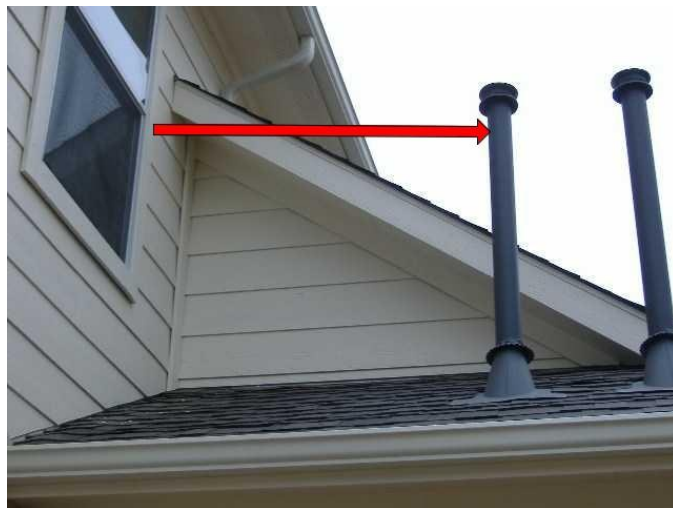
1. Water heater flue pipe termination is not the proper height when installed within 8 feet of a vertical wall. Termination should be 2' feet taller than any vertical wall within 8 feet.

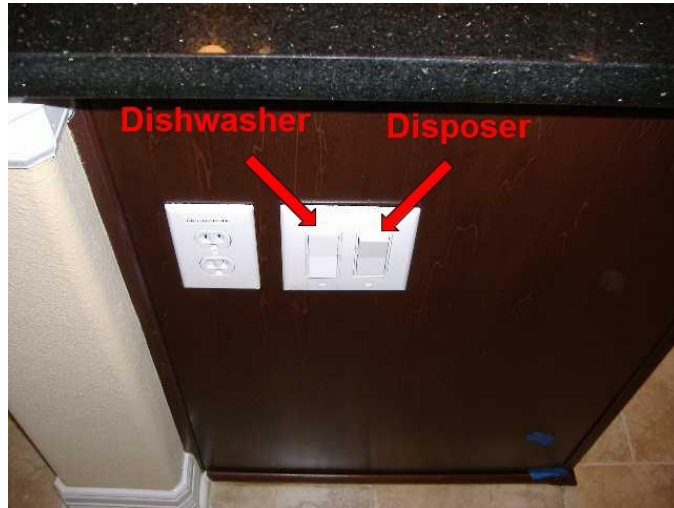
1. Kitchen food disposer switch is located on the cabinet base face. This positioning increases the likelihood of accidental actuation of the disposer. Recommend relocating switch.
